**US Army Corps  
of Engineers**

**USACERL Technical Report 96/55**  
March 1996

# **Field Application of EMI Coatings**

## **Investigation of Coating Materials and Stylus Electroplating Protocols for Shielded Facilities**

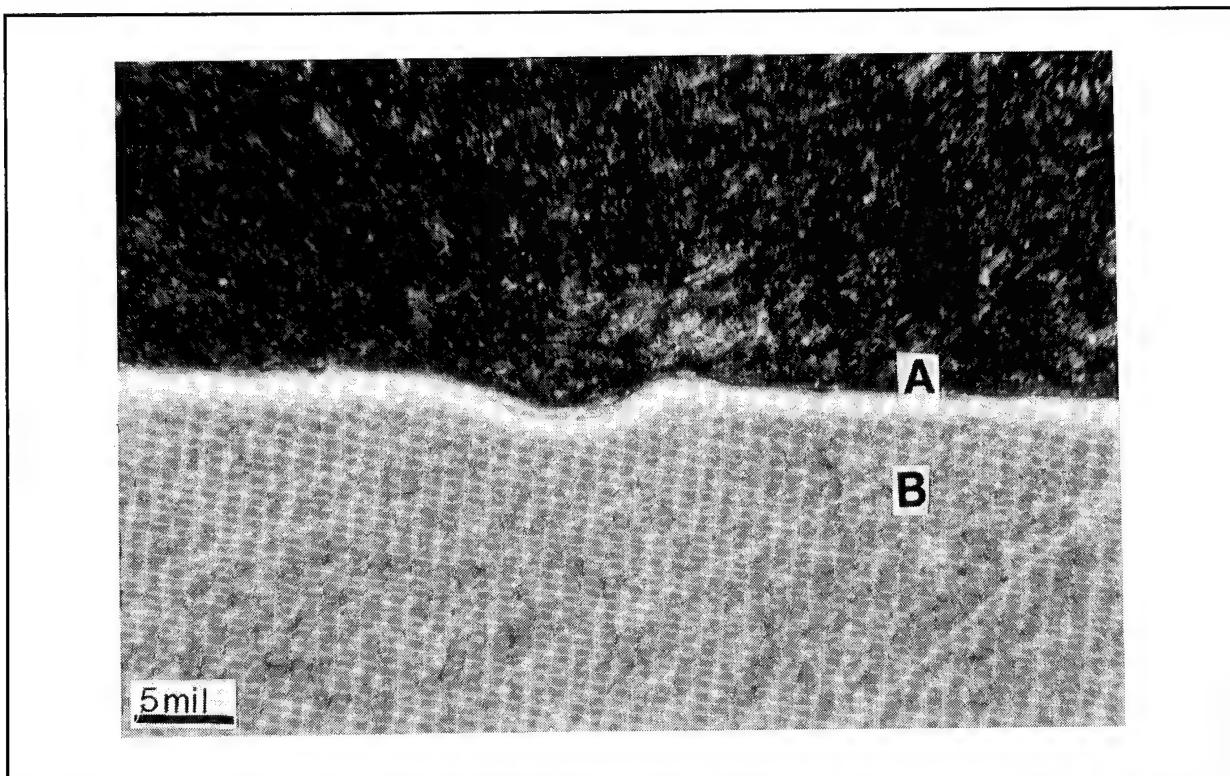
Figure 1.6. Optical micrograph of cross-sections of a 6061-T6 aluminum substrate scratched to a depth of 1.0 mil and then coated with 95%Sn/5%Pb over 60%Sn/40%Pb over Ni—(A) coating and (B) substrate of Sample 10 BF.

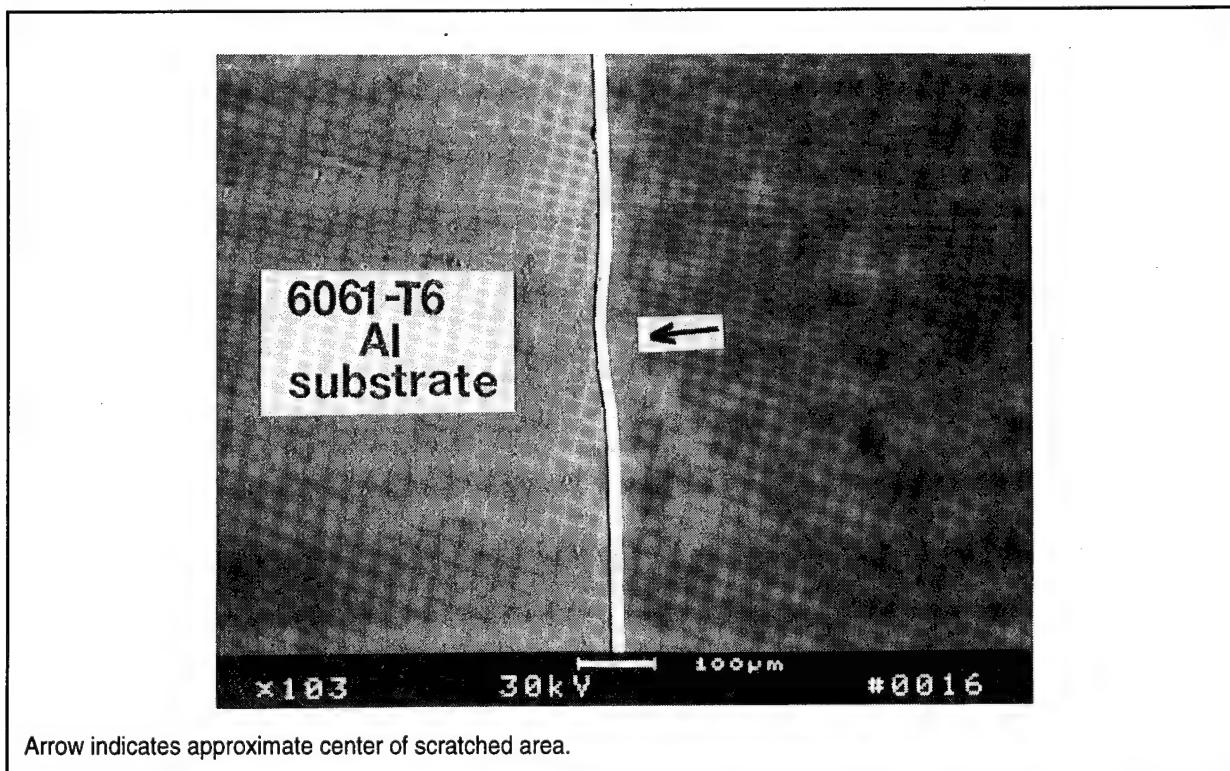
Arrow indicates approximate center of scratched area.

Figure 1.7. Scanning electron micrograph of cross-sectioned 6061-T6 aluminum substrate scratched to a depth of 0.5 mil and then coated with 95%Sn/5%Pb over 60%Sn/40%Pb over Ni.

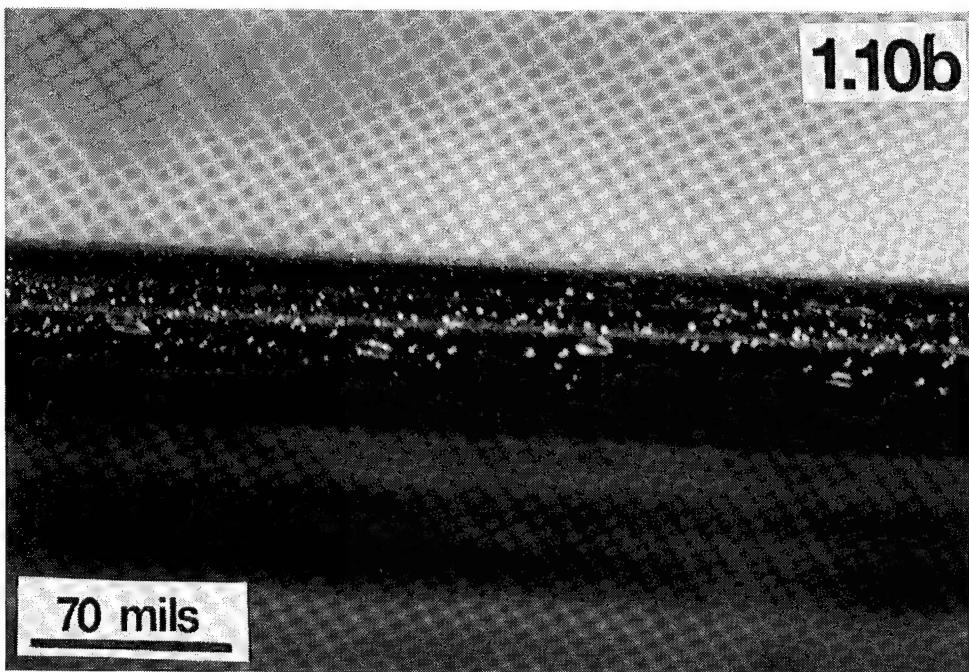
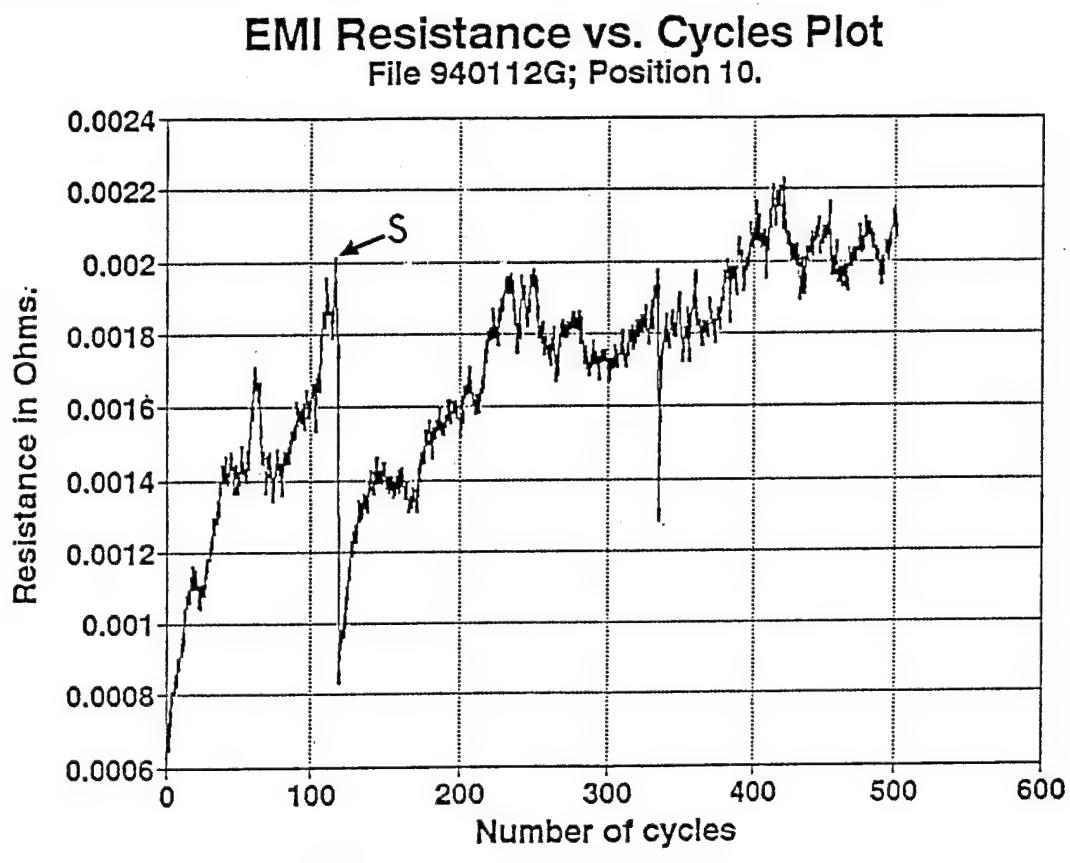
Figure 1.10. Optical micrographs of a Pb/Sn coated knife edge samples (a) 1KE and (b) 6KE, showing "bite marks" after 9,000 cycles on the USACERL Gasket Cycler Test System.

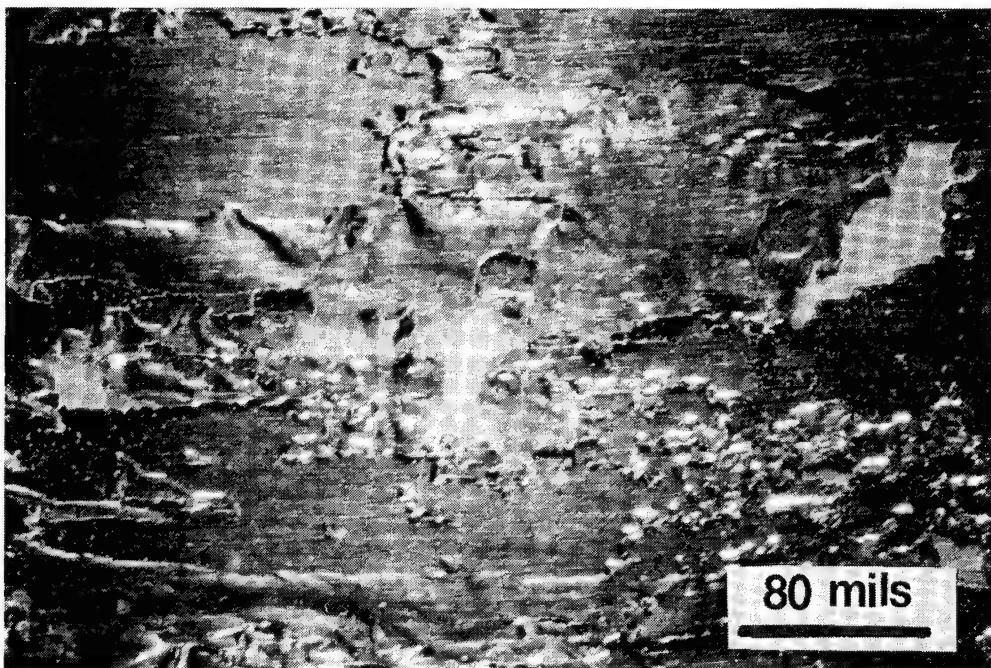
**Figure 2.3. Optical micrograph showing a broadface view of a poorly adhering tin coating deposit, probably caused by contamination of the electroplating solutions or the application pads.**

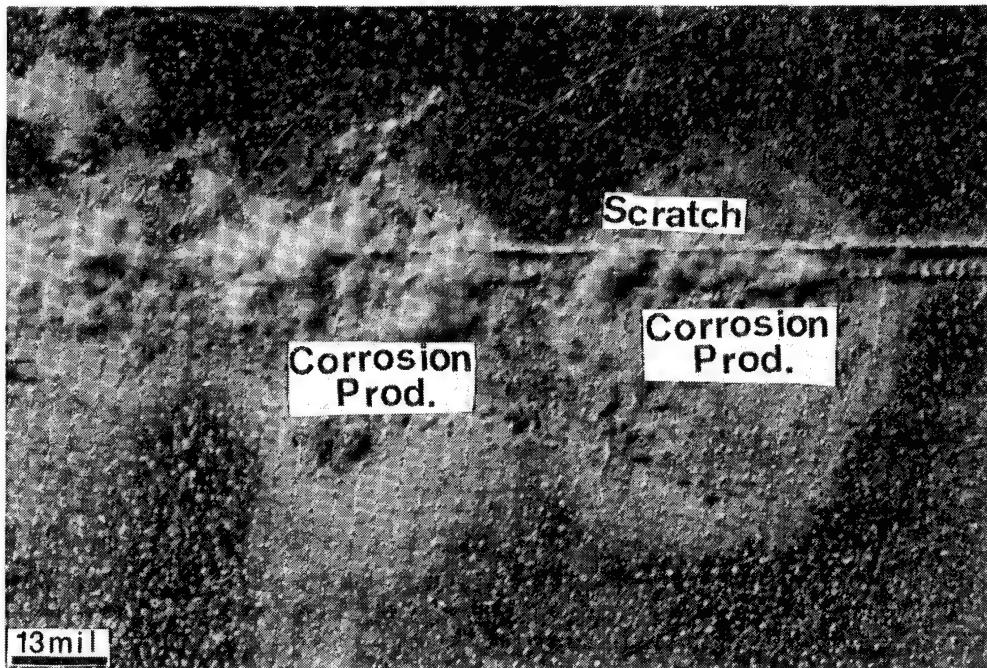
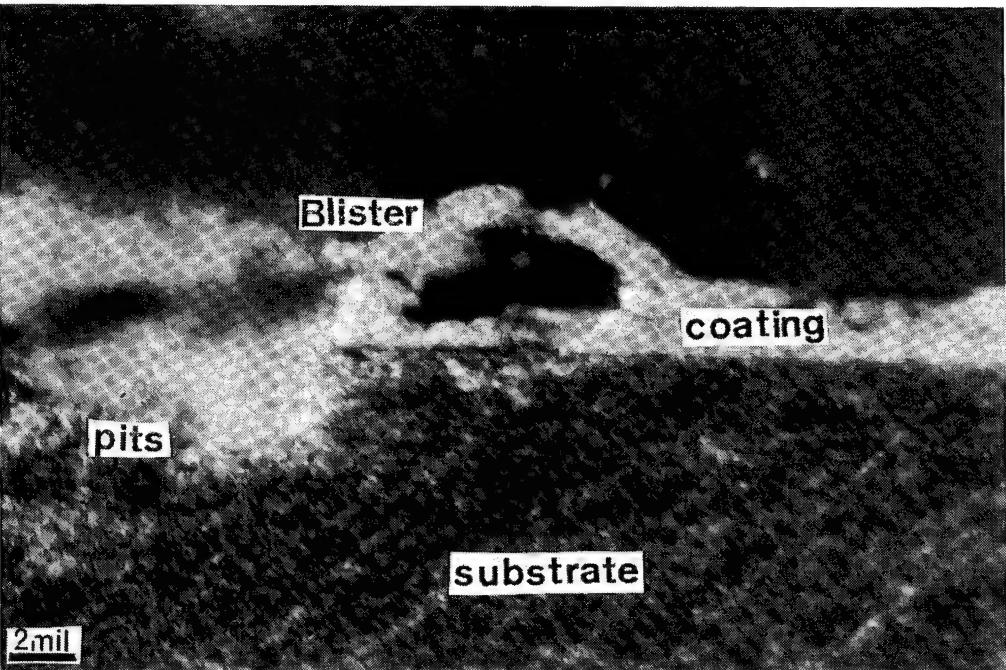
Figure 3.4. (a) Energy dispersive x-ray analysis of corrosion product and (b) Corrosion of aluminum substrate exaggerated by high cathode (Sn coat) to anode (Al) ratio.

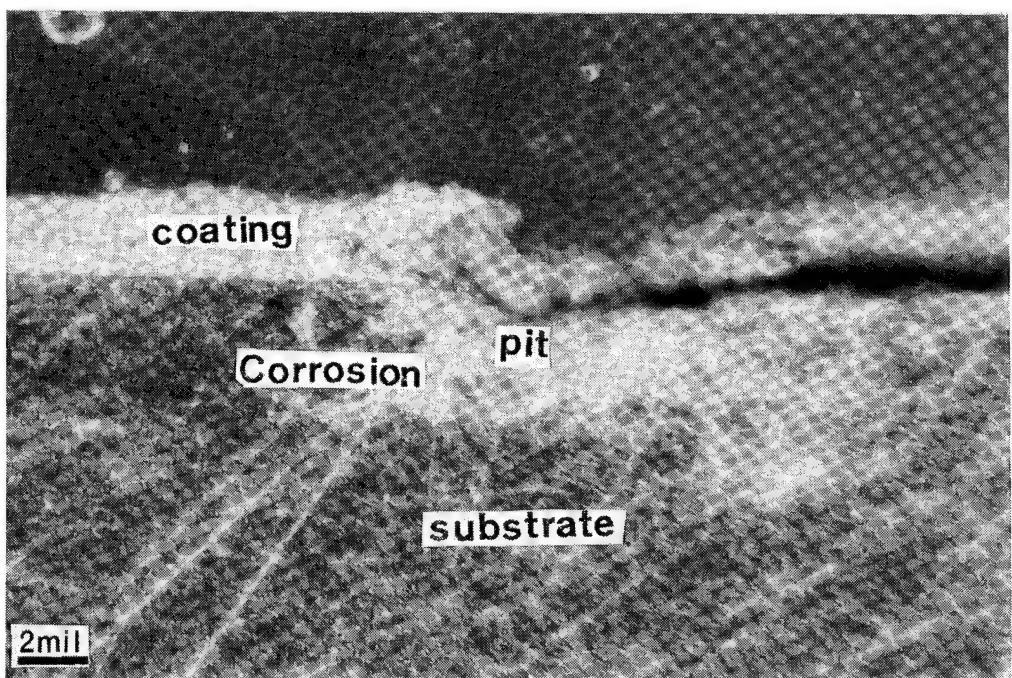
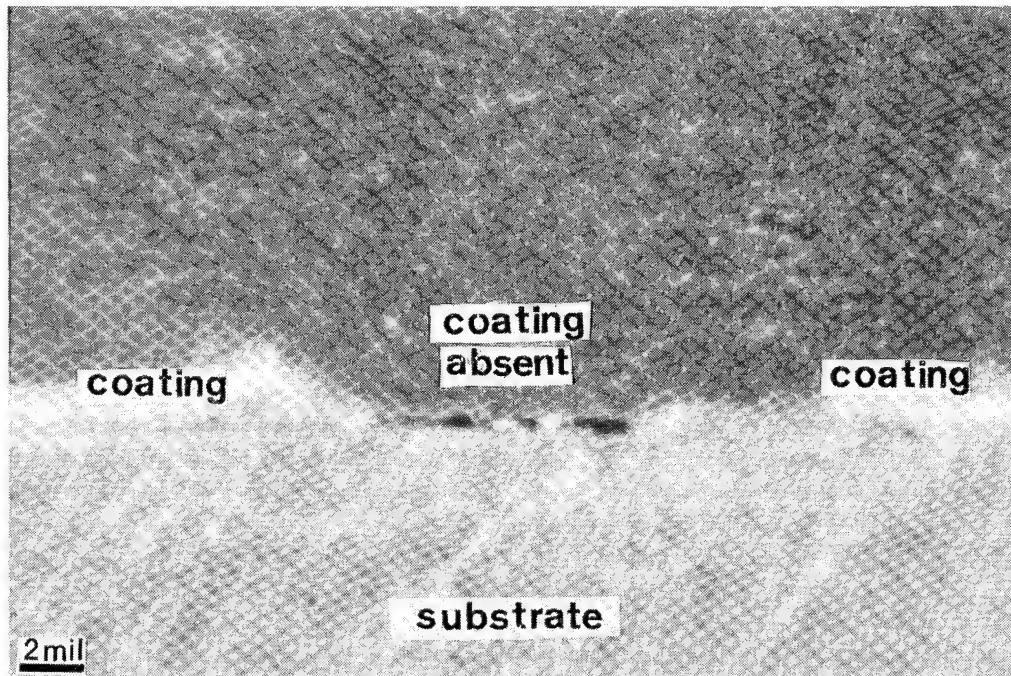
Figure 3.4. (c) Example of corrosion and salt product at defect (blister) on Sn plate and (d) same example with corrosion product removed.

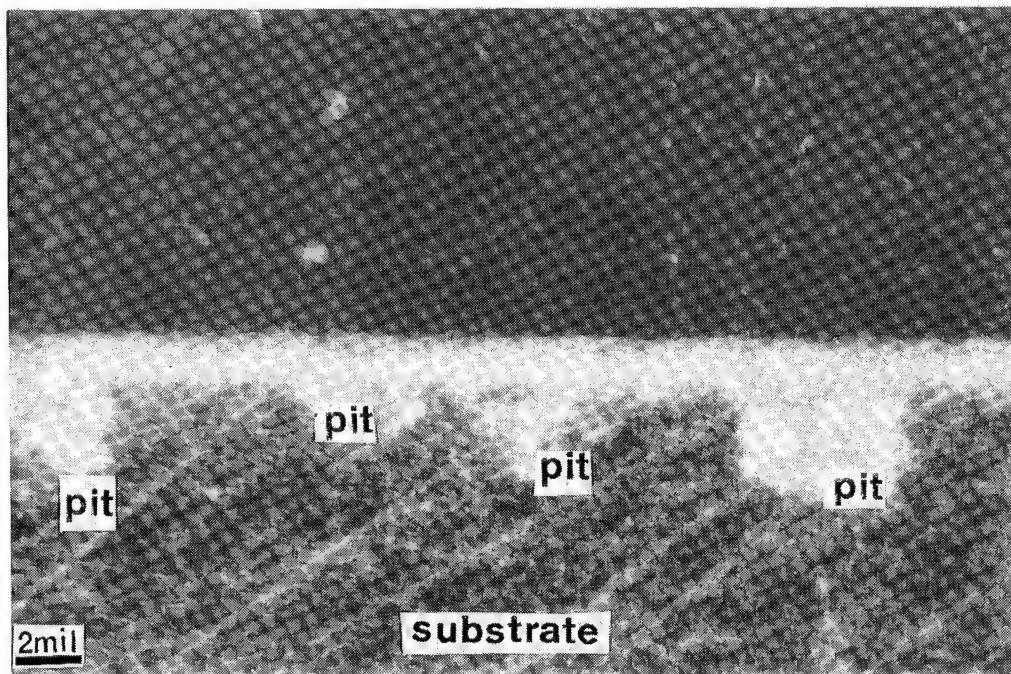
Figure 3.4. (e) Example of tin coating flaked away because of plating flaws that exaggerated corrosion of aluminum substrate and (f) pitting corrosion through tin coating and past nickel preplate.

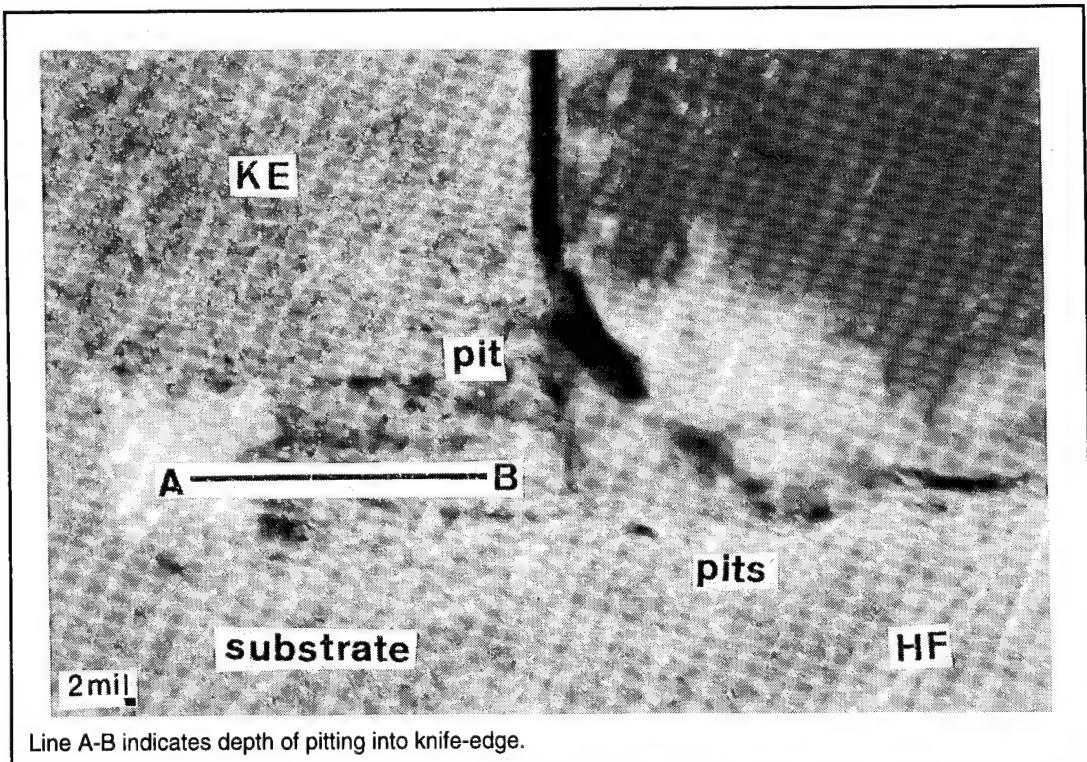
Figure 3.4. (g) Pitting corrosion in corner; cross-section shows knife-edge (KE) and half-face (HF) surfaces.

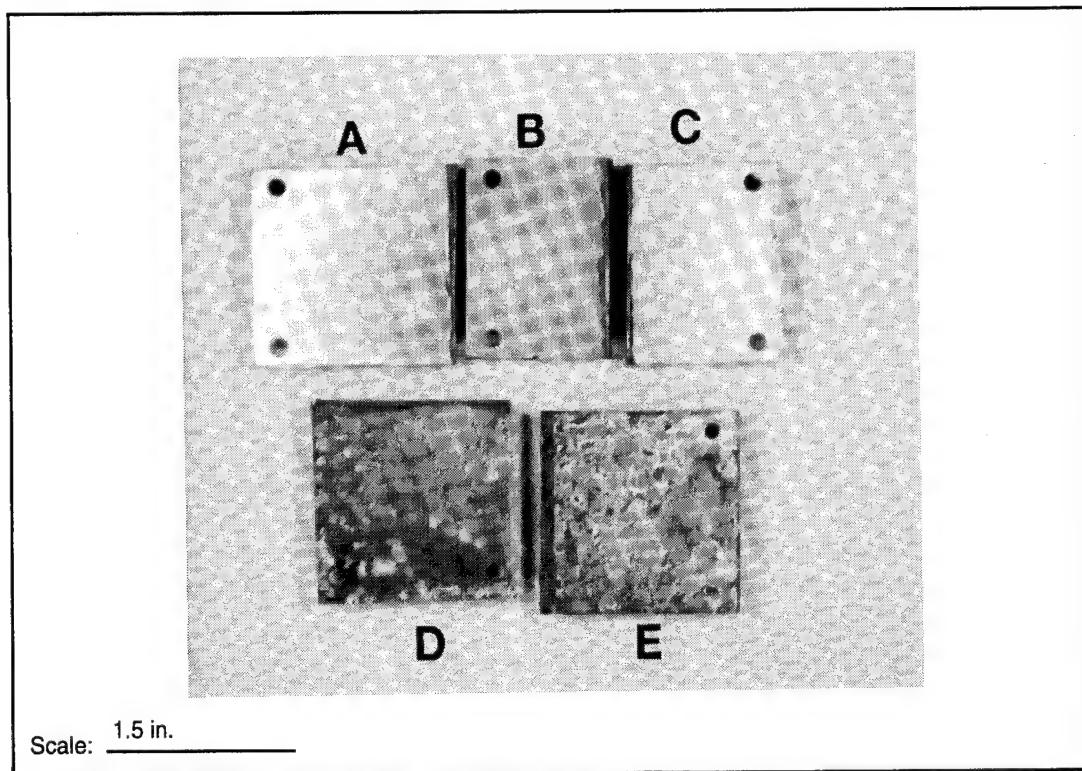
Figure 3.5. Post-salt fog test stylus electroplated samples of (A) tin coated; (B) uncoated; (C) tin coated; (D) nickel coated; and (E) copper coated.

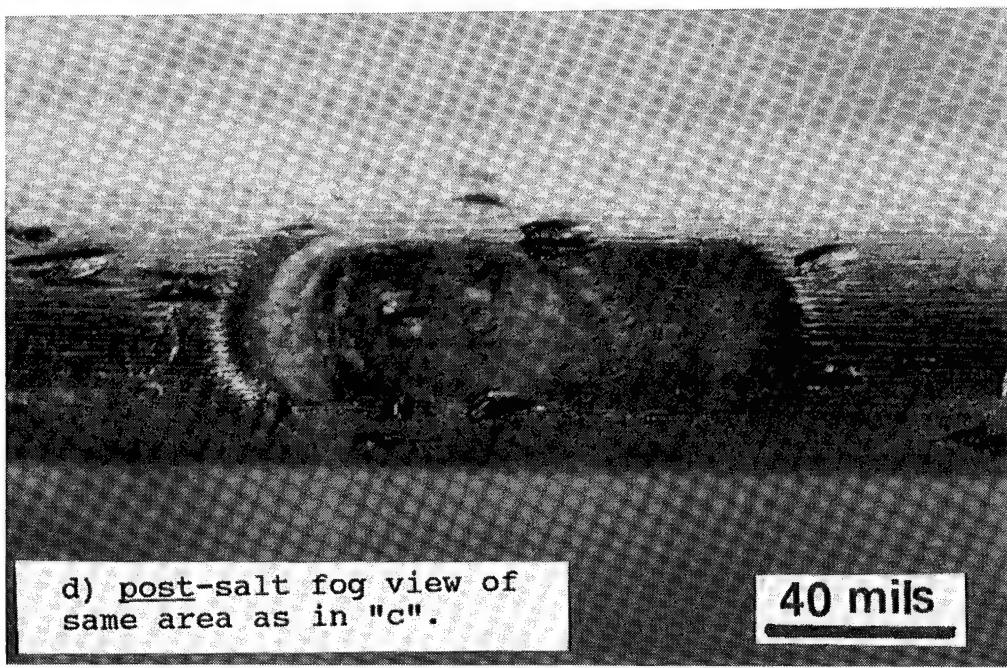
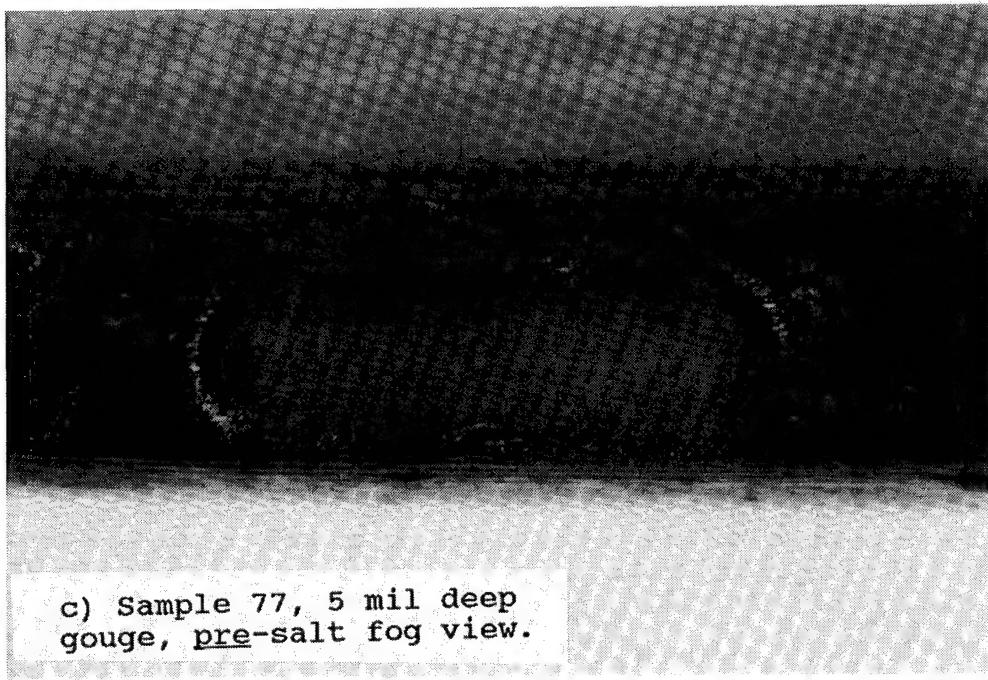
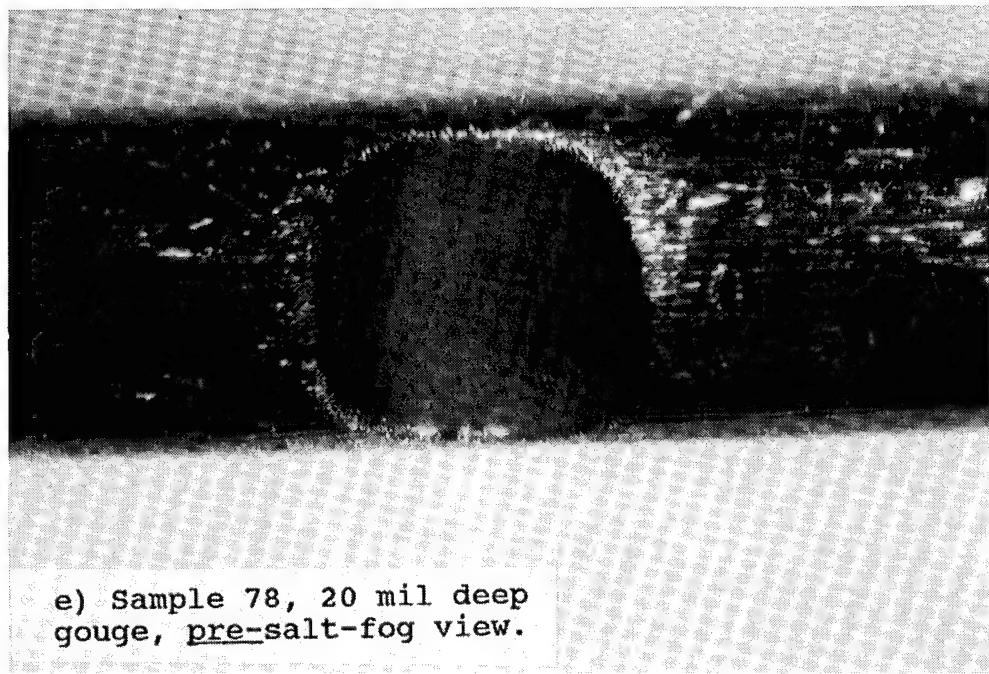
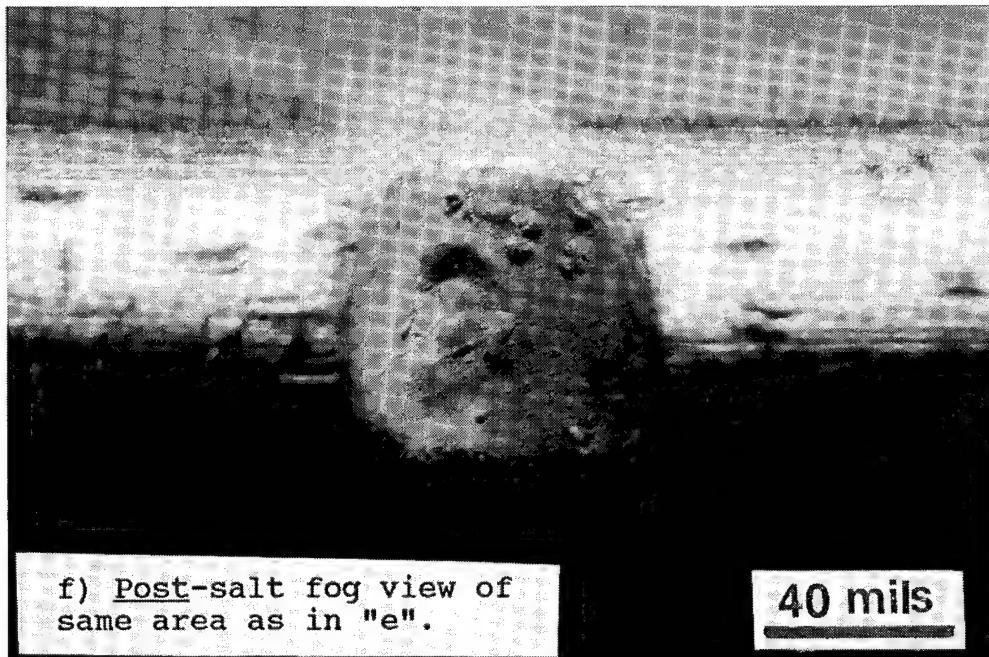
Figure 4.4. Micrograph of typical coated knife-edge samples showing the relative resistance of the coatings over intentionally gouged areas to salt fog degradation.

e) Sample 78, 20 mil deep  
gouge, pre-salt-fog view.
